**REPORT ON THE PUMP REPAIR
IN
COMMUNITY INSTITUTE FOR
DEVELOPMENT**

KAWAMA AREA, NDOLA

Pump Field Report

PR – 15 - 06 - 08

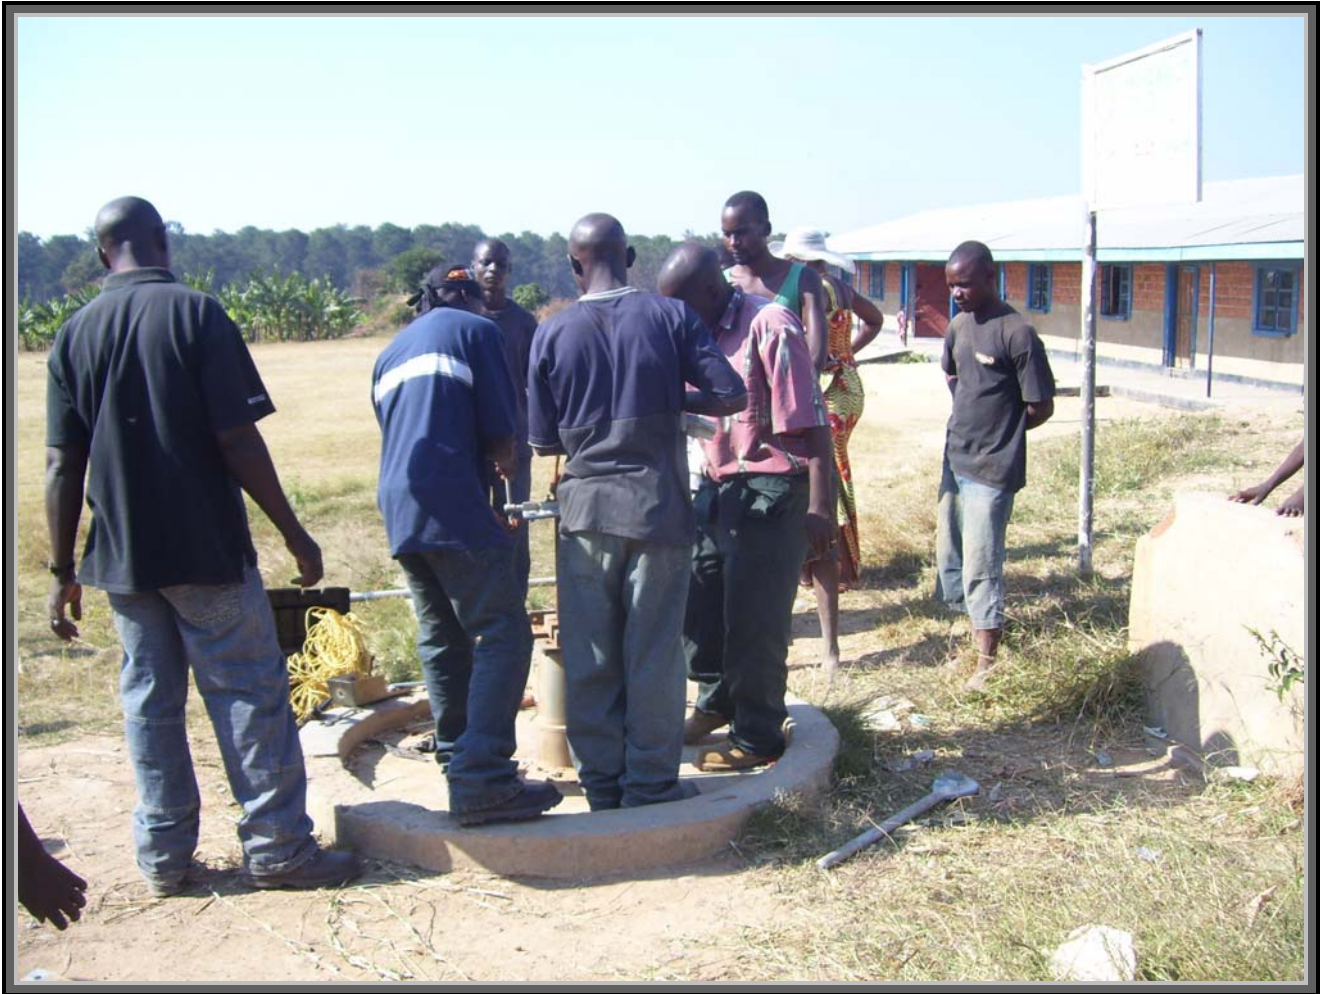
This is a pump repair in Kawama, at Community Institute for development

We discovered that some galvanized pipes were broken due to rust, and some connecting rods too were broken. The rest was in the process of breaking due to the rust.

We replaced four galvanized pipes, and five connecting rods. Pump resumes working normally.

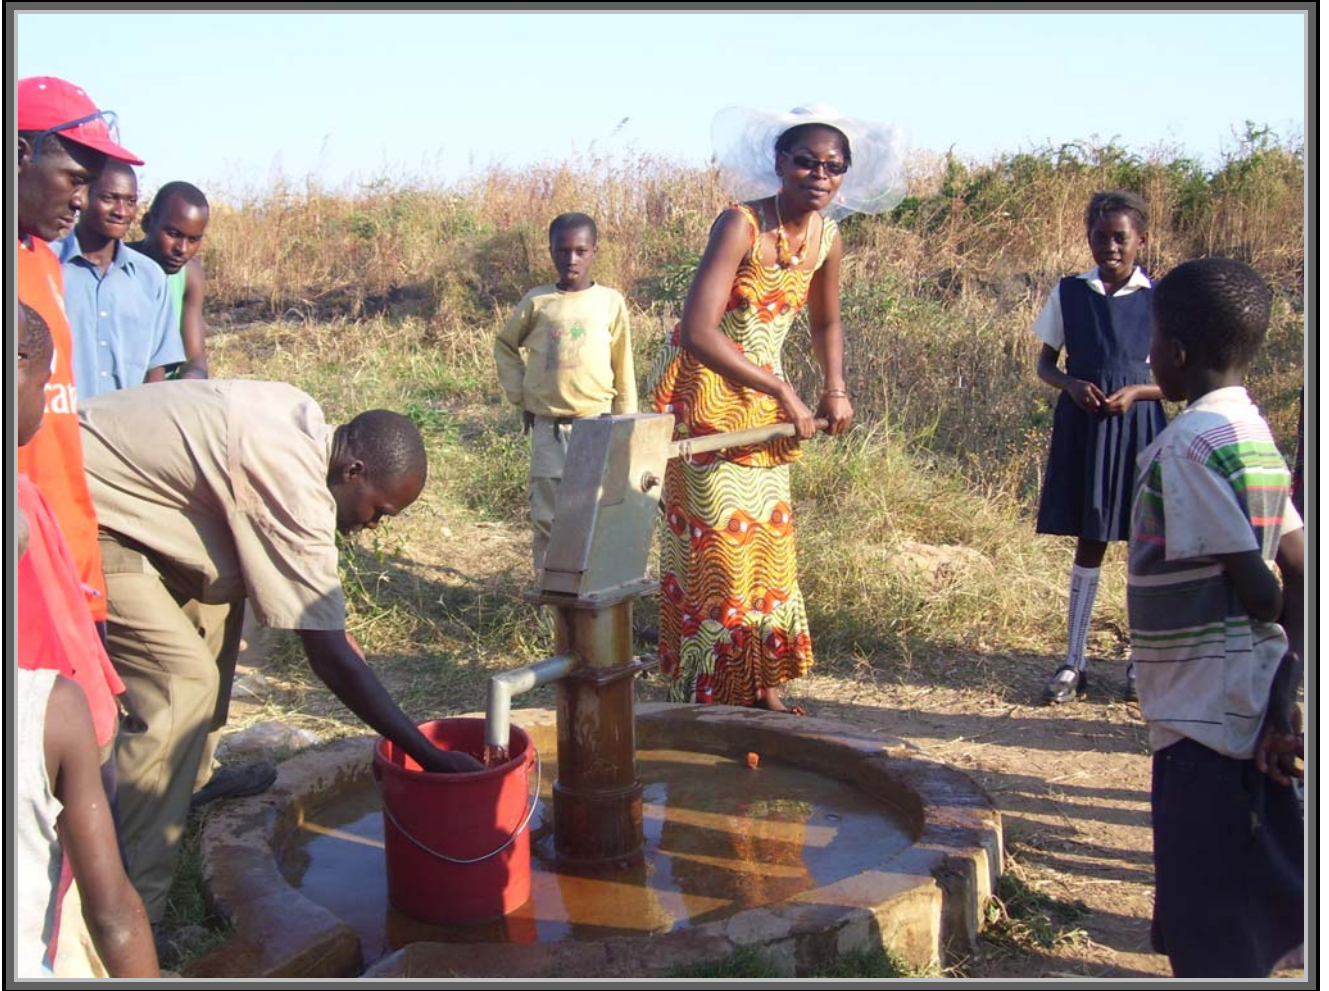
This is a restored pump which was not functioning for a long time.
