Name: Intulo Basic School	SHIP CODE: PR – 18 – 04 - 09
iWASH activity: Pump repair	Date of work: 30/04/08
Province: Copperbelt	Person completing this report: Kennedy Zulu
Region:	Funder: Thirst Relief
Community Name: Kawama	GPS (Lat) S12'54.770 (Long) E 028'36.797
Zone number: Nil	Location: School
Population: 2000 people	Direct beneficiaries of activities: 1848 community members, teachers and pupils
Community Contacts: [REDACTED] [REDACTED]	
Description of activities/training: Pump repair	
Common health issues: diarrhea and dysentery	
Community Response: The response was very good we had the head teacher Mr. Besa and his deputy Mr. Sitwamba and other teachers who help us with work.

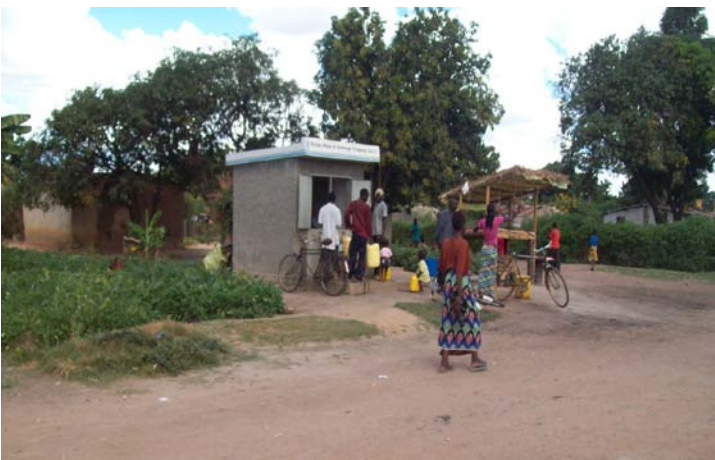
<p>This is a previous water source – a water Kiosk</p>

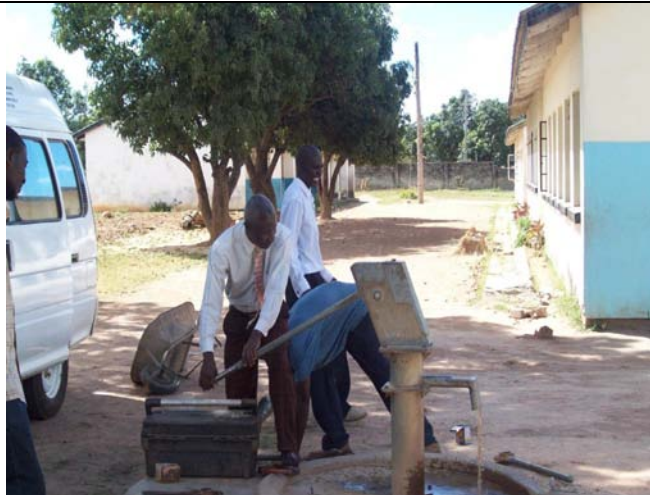
<p>After the repairs the school official, Mr. Sitwamba, tested the pump. He was very pleased with the results.</p>

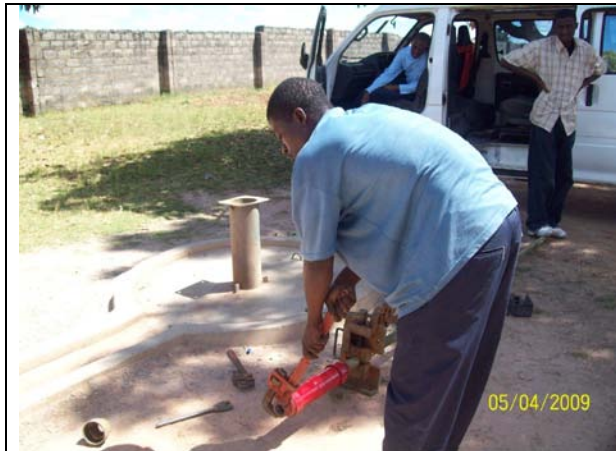
Kapuka Mubanga one of PR crew fitting the new cylinder

Achievements	<ul style="list-style-type: none"> • We achieved to retrieve the piston and the pipes that remained in the well. • Also managed to fit the new cylinder and the pump is working very well • People have access to safe and clean water
Materials used	<ul style="list-style-type: none"> • Cylinder
Recommendations/suggested follow-up/activities requests from community	The school Head thanked the organization for the good work they have done since the school had no water for quite some time and they depended on Kiosks, so now he is very glad to have water at his school.
