Name: Intulo Basic School	SHIP CODE: PR – 18 – 04 - 09
iWASH activity: Pump repair	Date of work: 30/04/08
Province: Copperbelt	Person completing this report: Kennedy Zulu
Region:	Funder: Thirst Relief
Community Name: Kawama	GPS (Lat) S12'54.770 (Long) E 028'36.797
Zone number: Nil	Location: School
Population: 2000 people	Direct beneficiaries of activities: 1848 community members, teachers and pupils
Community Contacts: [REDACTED] [REDACTED]	
Description of activities/training: Pump repair	
Common health issues: diarrhea and dysentery	
Community Response: The response was very good we had the head teacher Mr. Besa and his deputy Mr. Sitwamba and other teachers who help us with work.

Country: Zambia

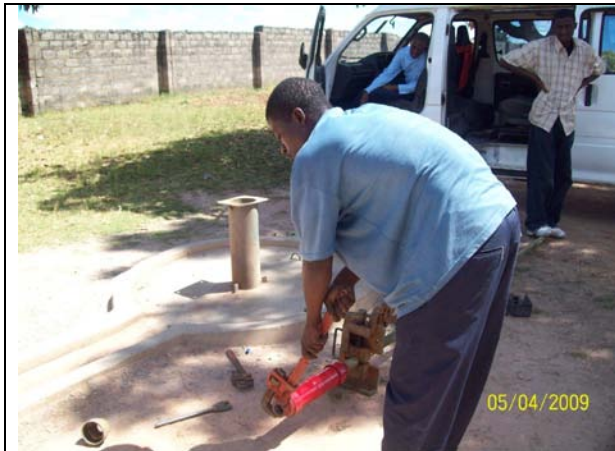
Kapuka Mubanga one of PR crew fitting the new cylinder

Achievements	<ul style="list-style-type: none"> • We achieved to retrieve the piston and the pipes that remained in the well. • Also managed to fit the new cylinder and the pump is working very well • People have access to safe and clean water
Materials used	<ul style="list-style-type: none"> • Cylinder
Recommendations/suggested follow-up/activities requests from community	The school Head thanked the organization for the good work they have done since the school had no water for quite some time and they depended on Kiosks, so now he is very glad to have water at his school.
