Name: Matipa Market Basic pump repair	SHIP CODE: PR-25-07-08
iWASH activity: Pump repair	Date of work: 10/08/08
Province: Copperbelt	Person completing this report: Justine Sondashi
Region: Masaiti	Funder: Thirst Relief
Community Name: Matipa Village	GPS (Lat) S 13'28.024' (Long) E 028'40.606'
Zone number: N/A	Location: Matipa Village Market
Population:	Direct beneficiaries of activities: 1000
Community Contacts: Mashane Sailas – 0977317556	
Description of activities/training: We provided them with a clean and protected water source. We also trained the pump minders	
Common health issues: diarrhoea, and dysentery	
Community Response: The communities of Matipa are pleased at the help rendered to them by Seeds of Hope by repairing their pump which has not been working for almost seven months.	
Other current iWASH activities in this location: None as at this period.

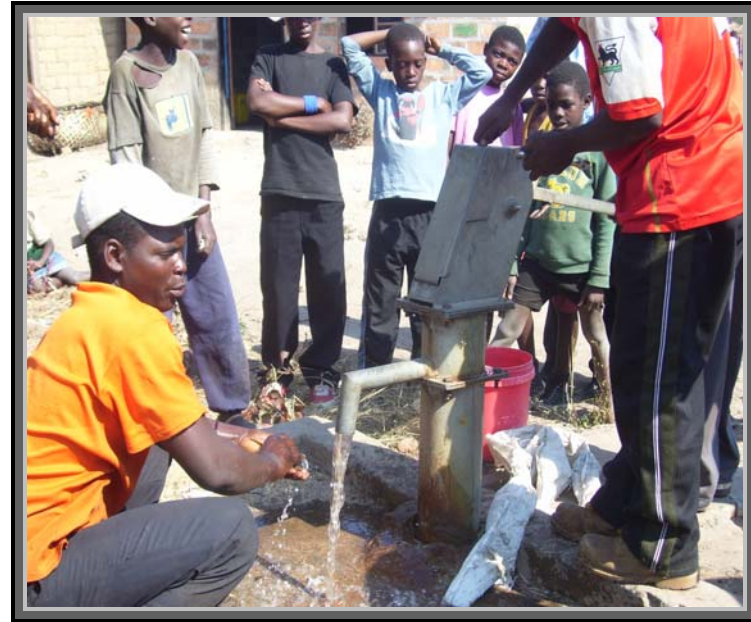
Final touches, but we have water running though.

Community Contribution	NIL
Pump caretakers trained	Christopher Banda, Laston Fingele, and Thomas Kafwasa
What are the community's previous water source(s)?	Hand dug wells
Describe pump repair	The cylinder, rods and pipes were dropped in the well by some people who had attempted to fix it. Unfortunately, they failed to fix the well because it is very deep. We could not manage to fish out the parts and resolve the problem.
Describe how the work progressed	We put in a new cylinder, seven (7) connecting rods, and seven (7) Galvanized pipes.
Measurements/ well log	Depth 49m water level 9m pipe used Galvanized pipes Casings used P.V.C Pad poured Yes Pump used Indian Mark II Soak away pit Yes Fence style NIL
Achievements	The people of Matipa market, including the surrounding communities, now have safe drinking water.
Materials used	Seven (7) Galvanized pipes Seven (7) rods One (1) cylinder
Recommendations/suggested follow-up/activities requests from community	We would like to start by seeing the men who made the first attempt to fix the pump so that we can train them and teach them how to handle such situations
