REPORT ON THE PUMP REPAIR

NKWAZI MIDDLE BASIC SCHOOL
NDOLA AREA

Pump Field Report

PR – 23 - 06 - 08

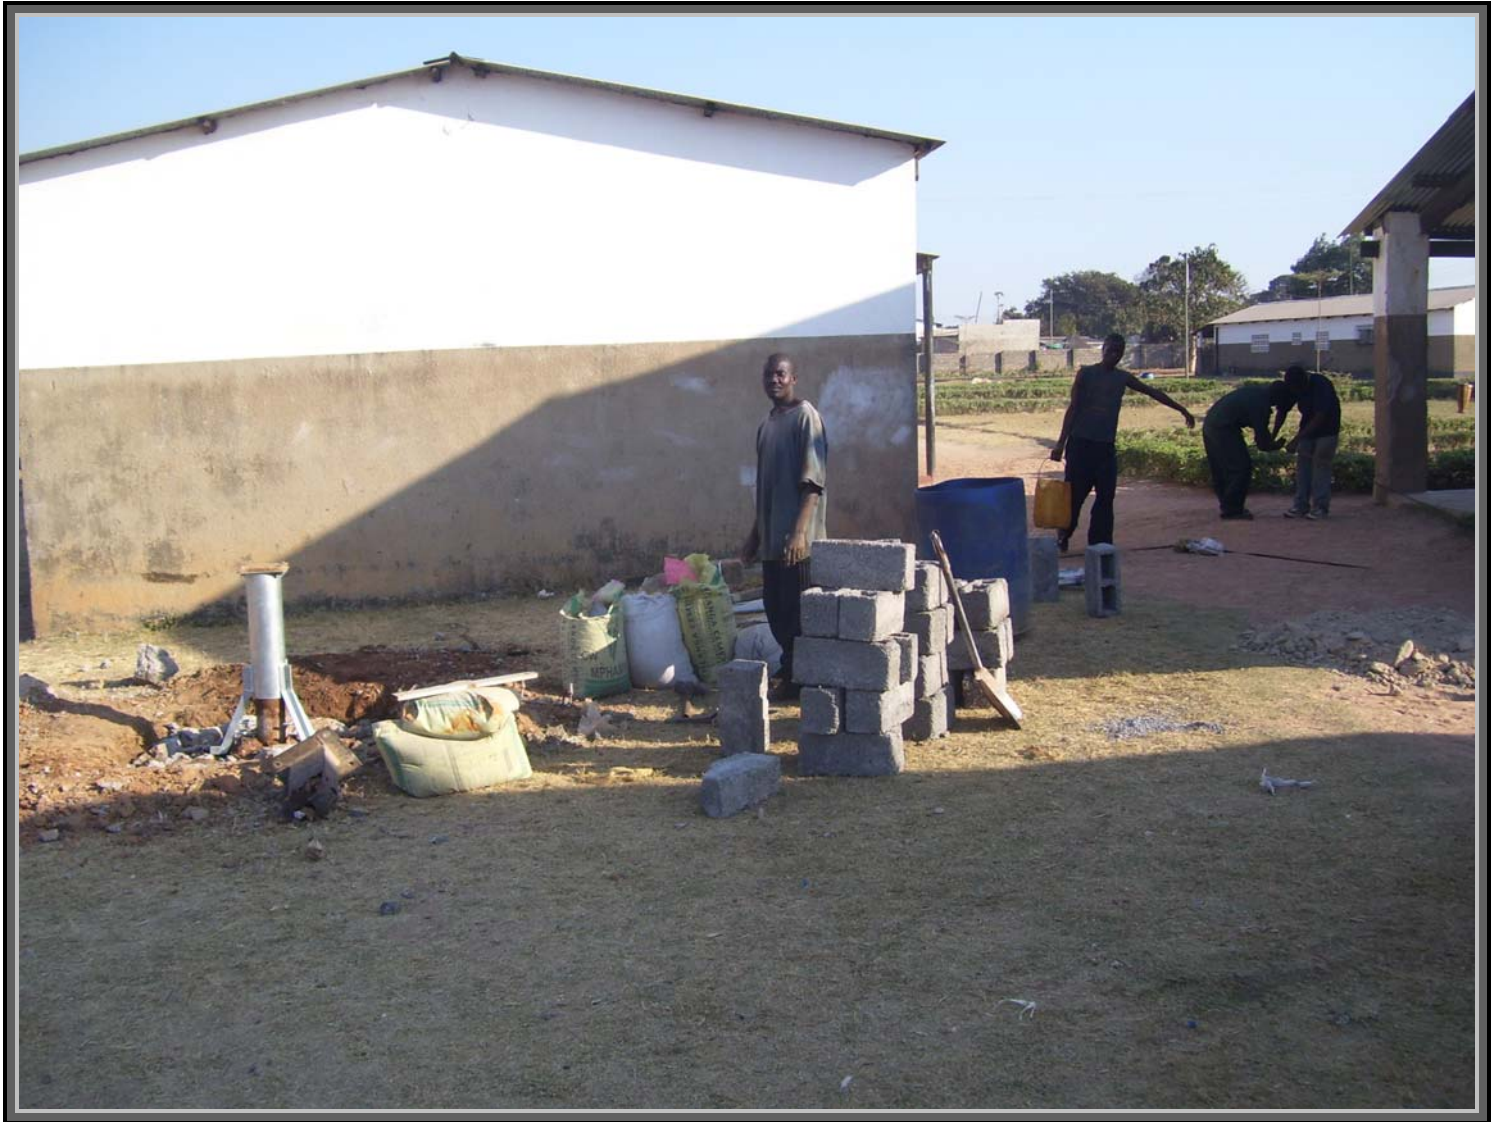
Apron construction, Nkwazi middle basic school.

- **Erected a York stand**
- **Constructed an apron**
- **Installed new Indian Mark II fittings**

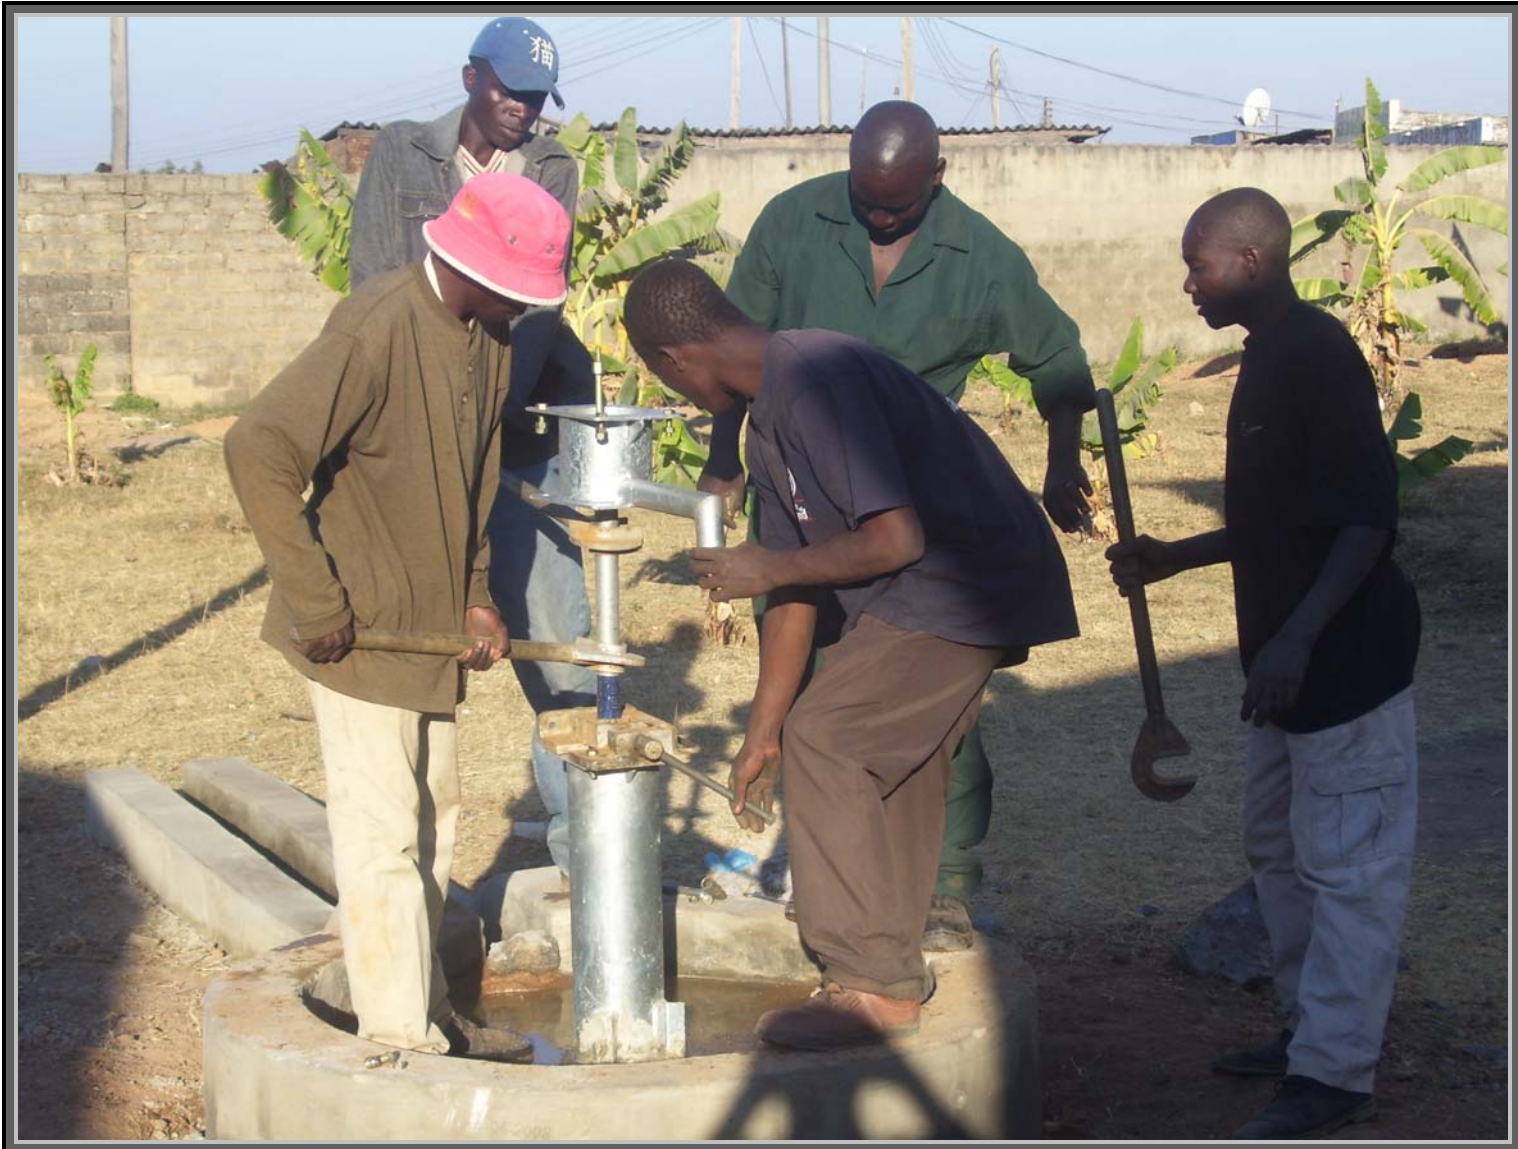
That's the new pump being fixed on the borehole.

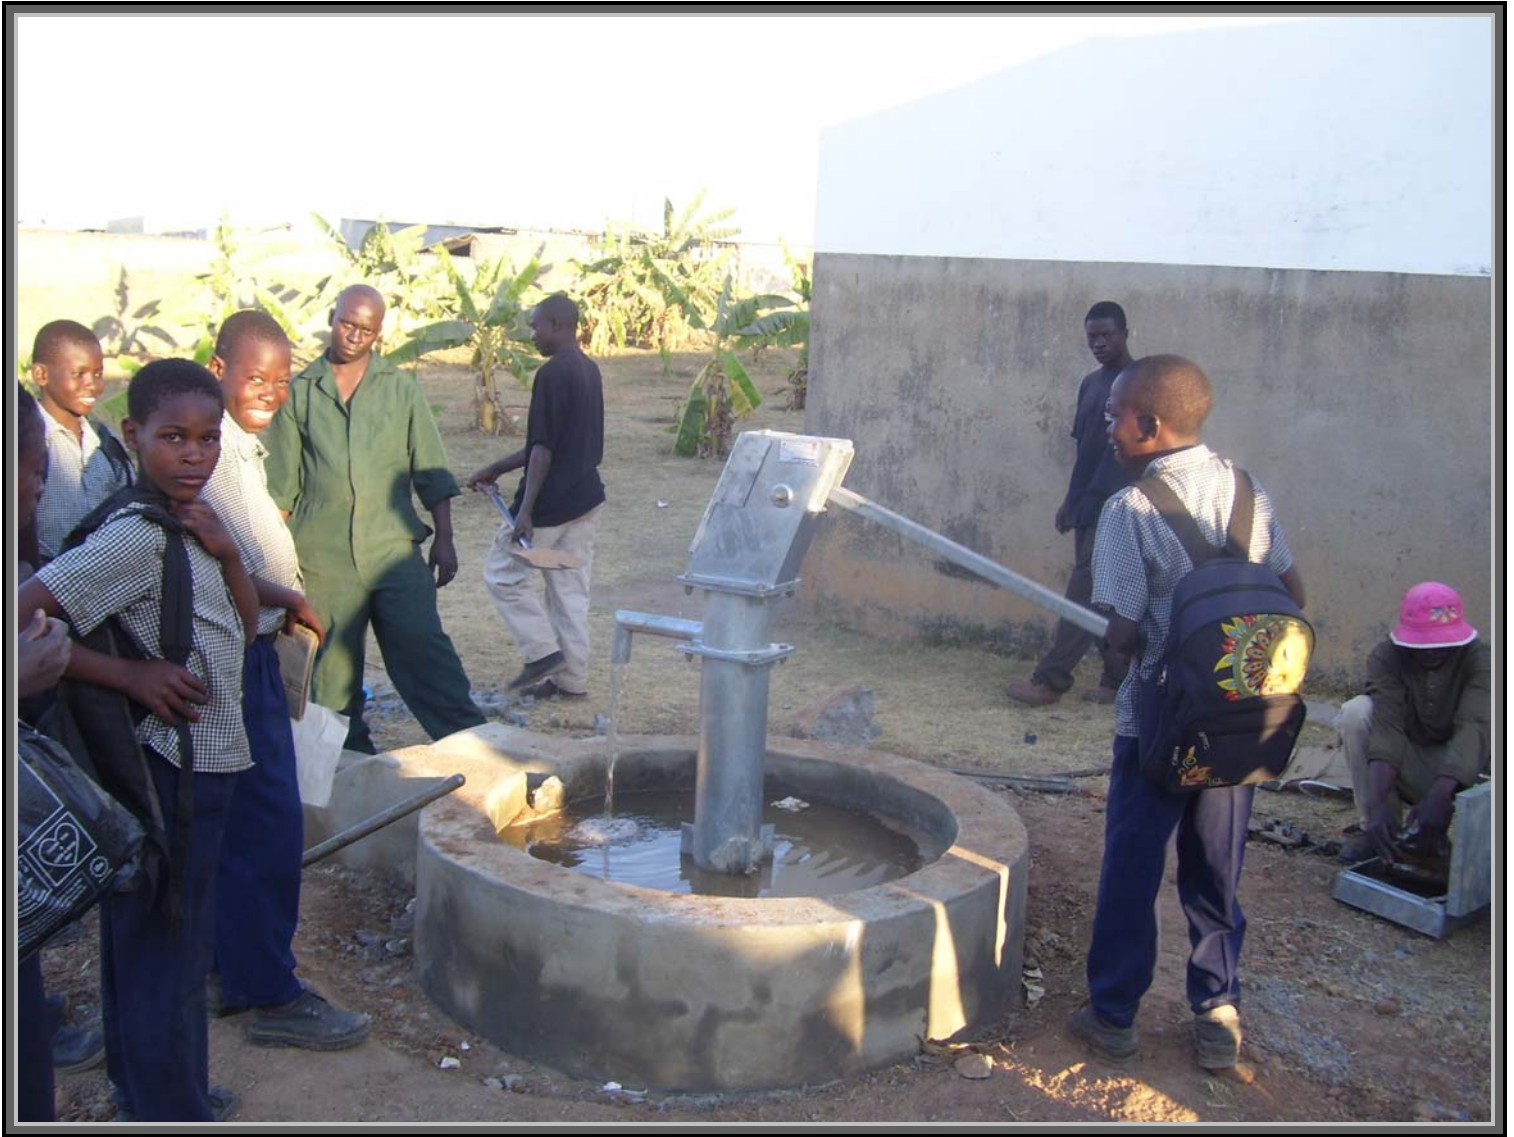
Here goes the newly installed pump; we have water for the school.
